Make mine melamine

Brad Thompson, Contributing Technical Editor brad@tmworld.com- December 1, 2008

Make mine melamine, part 2

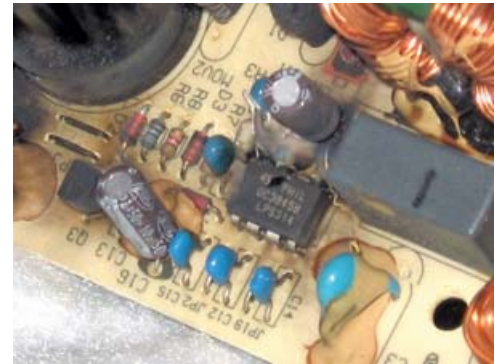
Applying AC power by plugging in the power cord produces a muted “pop” and a flash of light, followed by the release of a small puff of smoke—all originating from the PC's power-supply subassembly. Removing the power supply's cover reveals several severely damaged components.

The power supply's construction comprises discrete through-hole components mounted on single-sided printed-circuit boards. A sheet-metal enclosure protects the assembly, and a small fan provides cooling (and smoke) dispersal. The power supply's label bears several safety-agency approval and recognition symbols.

The power supply's Chinese manufacturer applied generous amounts of an eggshell-colored and porous sealant to stabilize components mounted on the circuit board. The sealant darkens with exposure to heat and time. It also becomes conductive, creating multiple sneak paths among components. Inserting an ohmmeter's prods in random globs of sealant shows resistances in the 1-to-10-M Ω range. That's enough to inject small amounts of AC into the primary-side switching components and cause uncontrolled circuit activity.

We've reverse-engineered portions of the power-supply circuitry and determined that Revision B (or higher) power supplies contain a white sealant that's presumably nonconductive. To date, these power supplies haven't exhibited the failure mode.

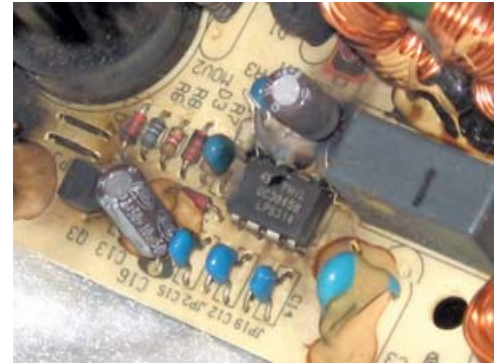
A Google search for "conductive brown glue" finds more than 100,000 references, some of which mention the glue's role in various CRT display problems and its use in consumer audio equipment. Searching for "chloroprene adhesive," Google finds 56,000 references, including one from a Sony division that contains the following cautionary note: "The products...contain chloroprene rubber.... Prolonged standing in a high-temperature environment...may cause thermal dechlorination, possibly resulting in the corrosion of metal parts nearby, or in a loss of insulation resistance. Please be sure to avoid any use of these materials in electronic components that are to be energized electrically to prevent tracking or similar problems."

As the second reader suggests, given informal procurement processes, it's possible that a subcontractor used inferior glue to attach components. An archived e-mail note conjectures that "...The plain gummy petroleum glue is ok over time, but [there's] a problem with a filler/bulking agent used. I agree that it goes brown with age, [so] perhaps it's a corn flour or vegetative starch filler. I doubt a mineral [filler] like talcum or French chalk would discolor to a very dark brown or become a problem...."
